US Army Corps
of Engineers

Bridge Inspection Program

FY 93 Routine Inspections

October 1993

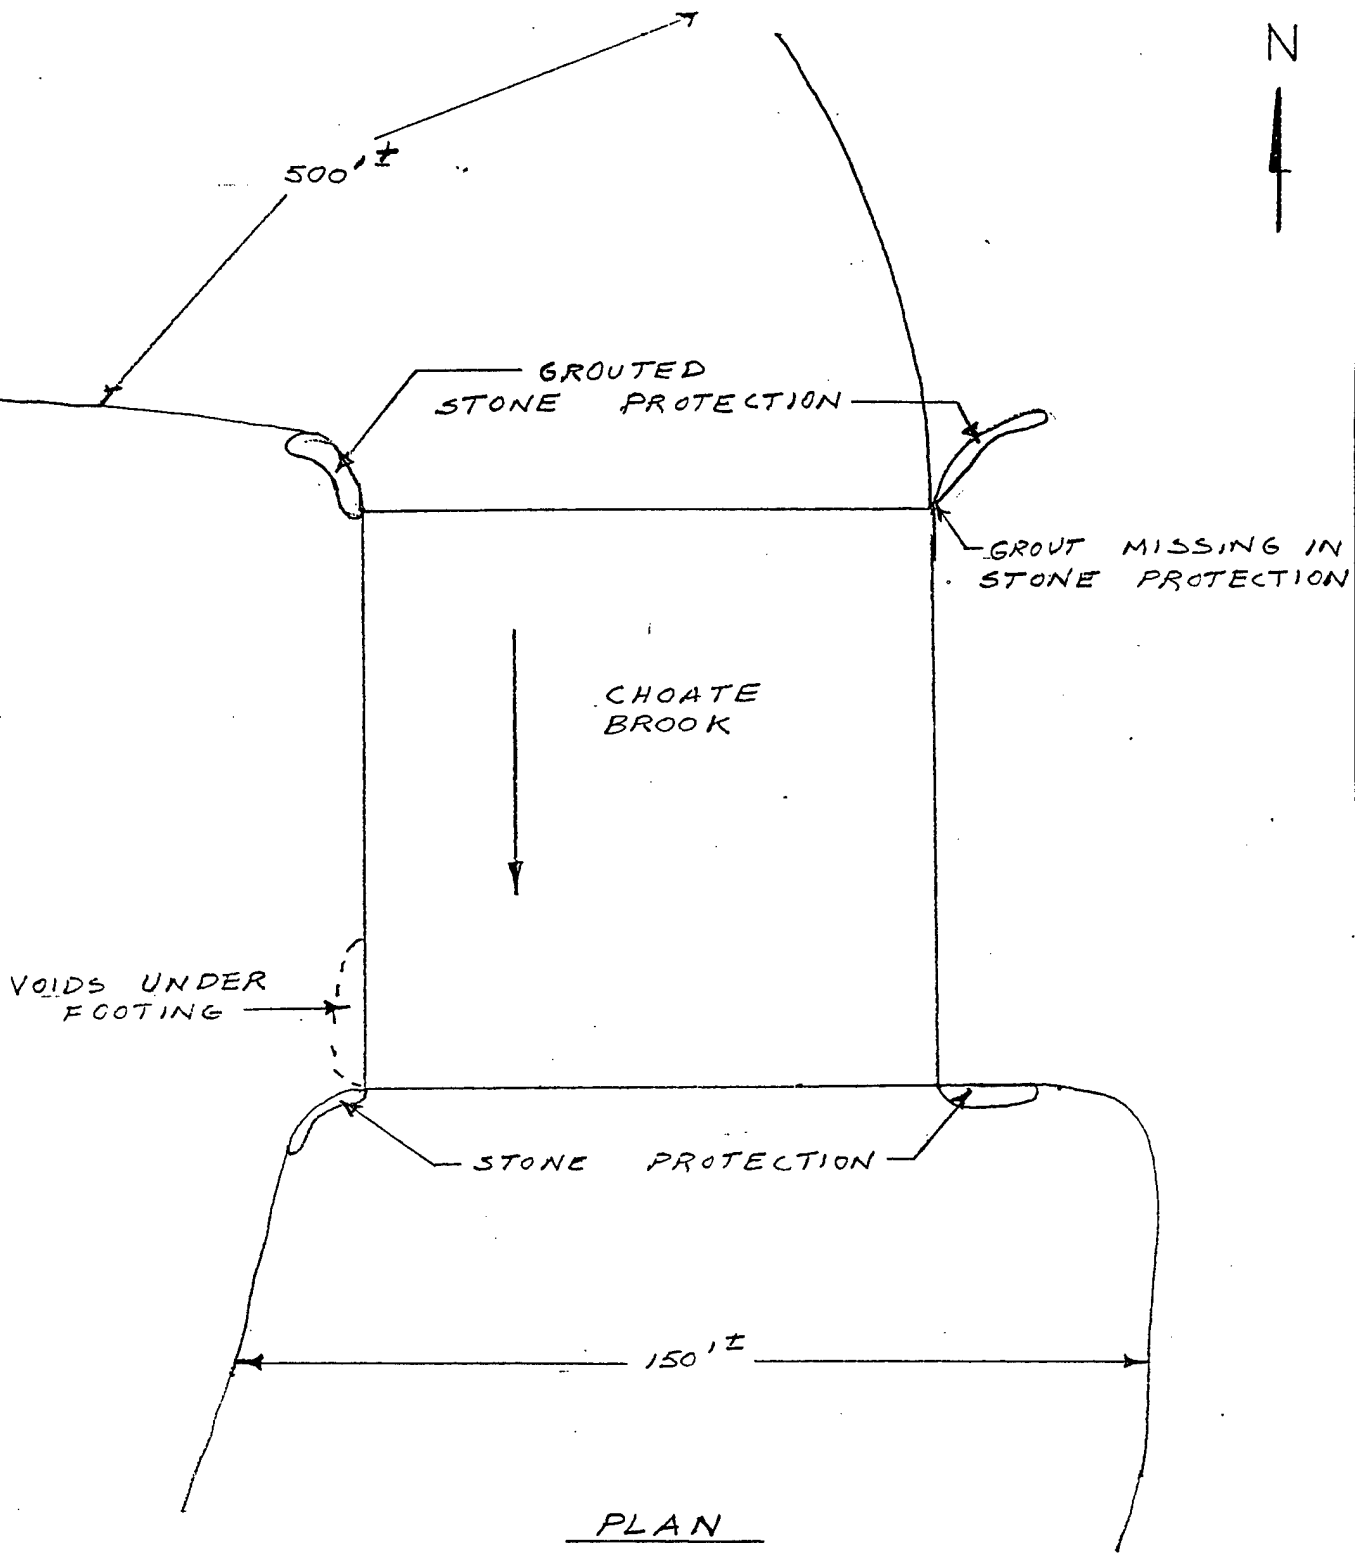
PS	CHOATE BROOK BRIDGE SKETCH BRIDGE SCOUR STUDY HOPKINTON-EVERETT LAKES
DES. BY	
PS	
DR. BY	
CK. BY

It is recommended that the beaver dam that was observed upstream of Choate Brook Bridge be removed. It appears that the dam might slightly alter the hydraulic characteristics of the stream and cause eddy currents which could lead to additional scour near the bridge. Rental of a small truck and a few hours of hand labor would be needed to remove the debris.
